**2007 Sea Ray 310 Sundancer**

***"Pura Vida"***

# **REPORT OF MARINE SURVEY**

**July 01, 2011**

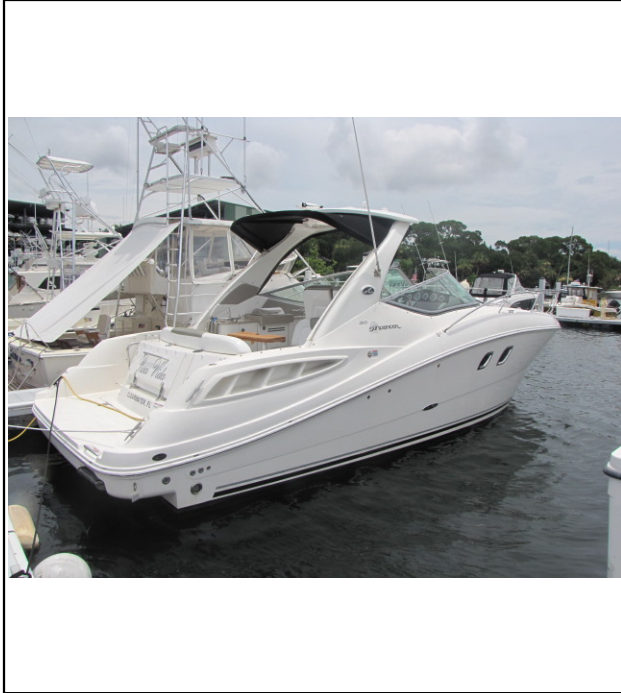
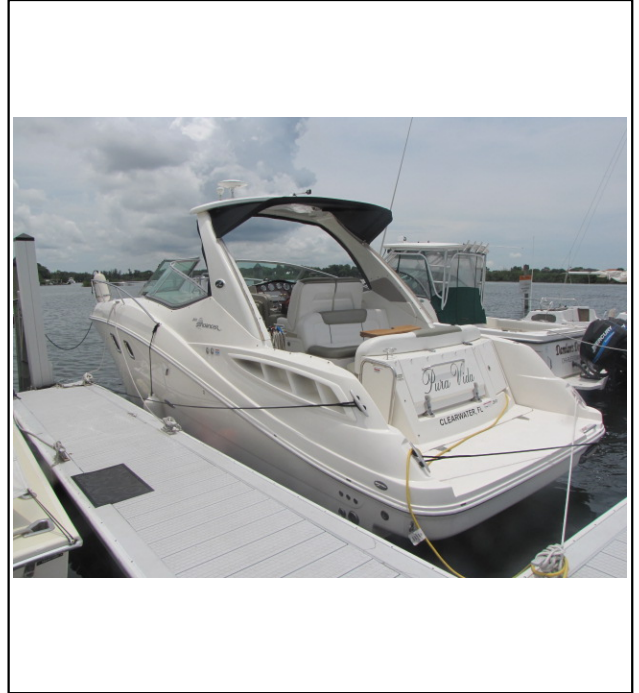
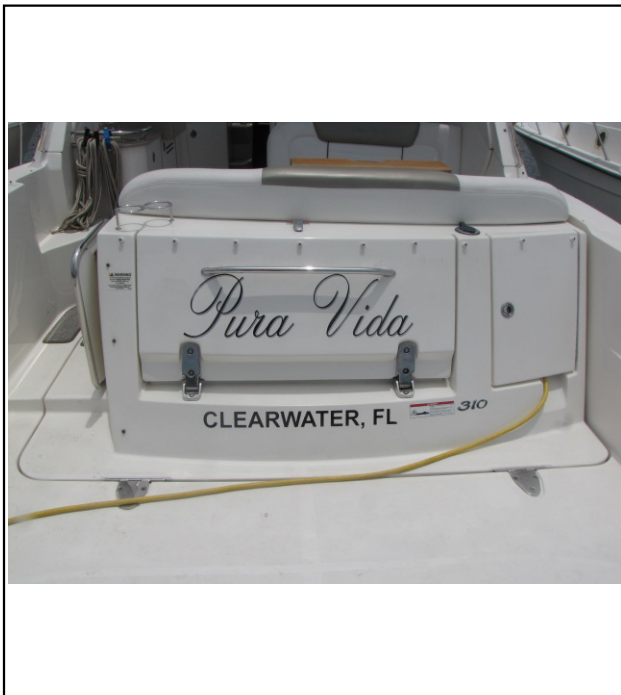
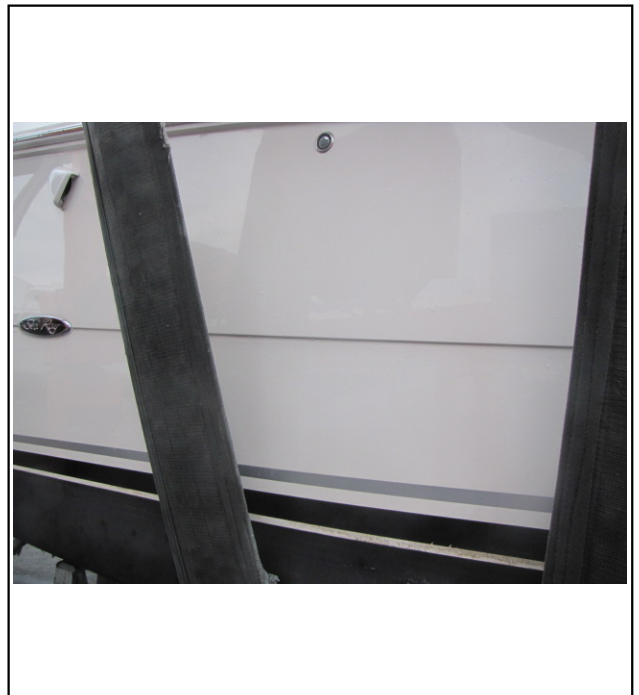
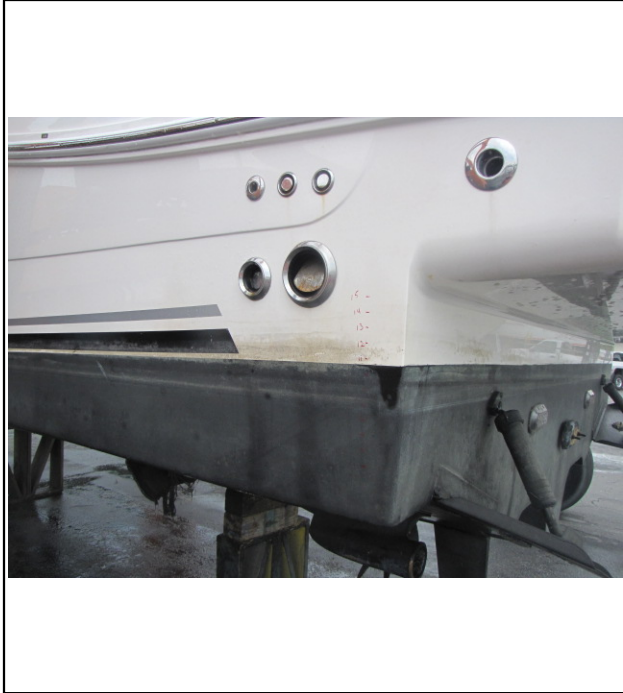
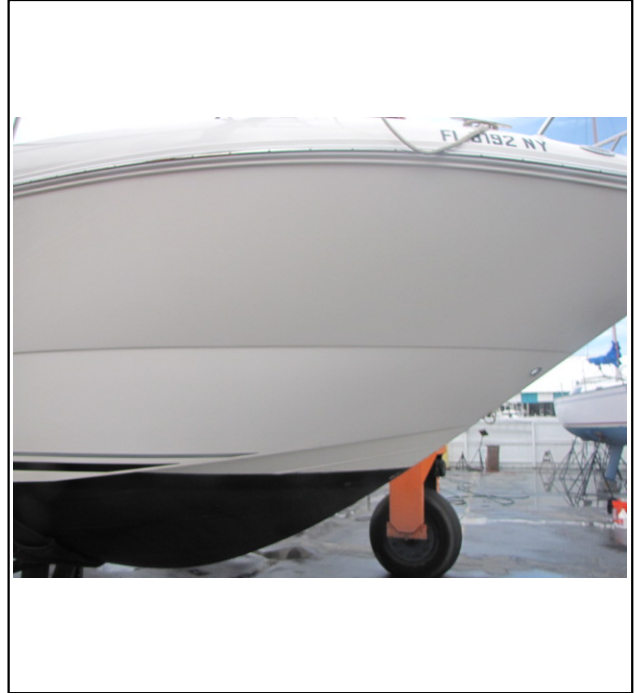
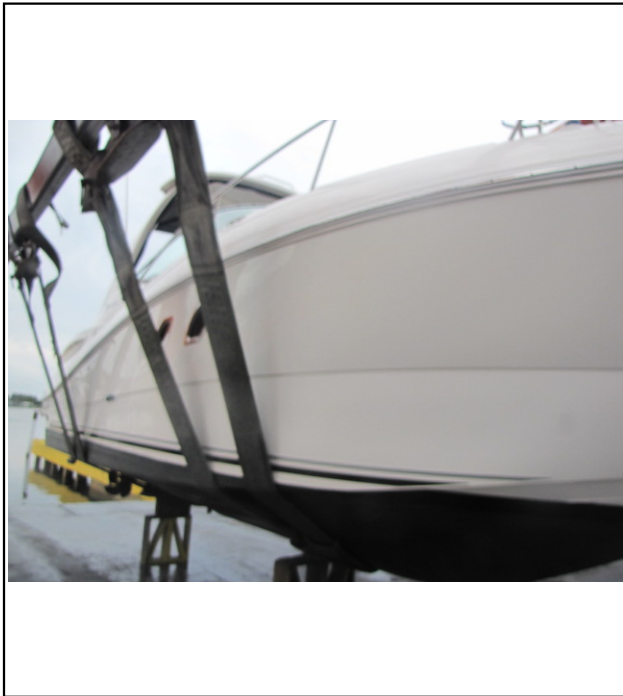
White gel coat with a black boot stripe. Hull appeared in excellent condition with no obvious damage to gel coat. Hull has a good shine and has been well maintained by captain. Boot stripe port and starboard at sling area has a slight tear from lifting straps. See photo's 1,2,3,4,5,6,7. Serviceable.

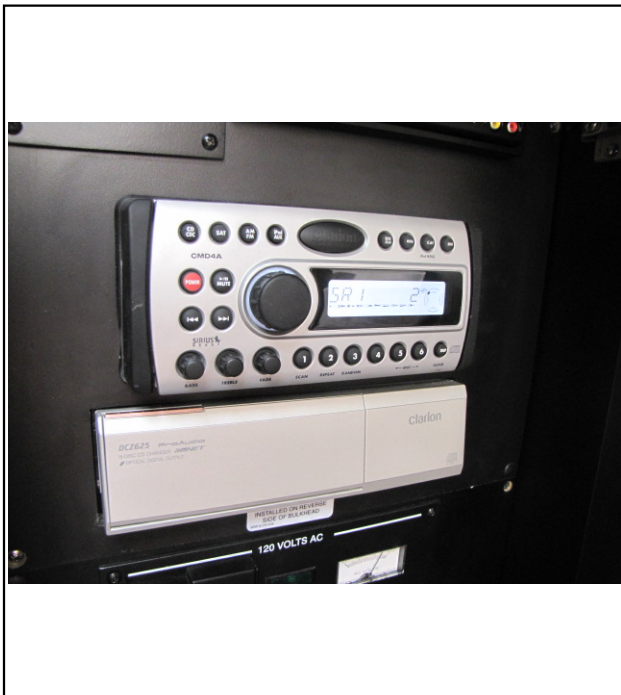
Clarion radio/CD changer, photo 11.

Clarion, model CMDA Sirius ready with a Clarion , model DC2625 6 CD changer. Powered up. See photo 11.

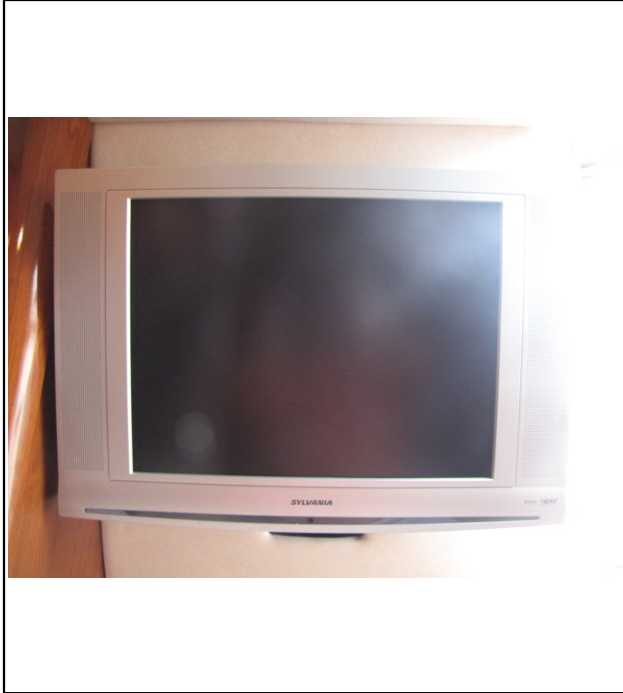
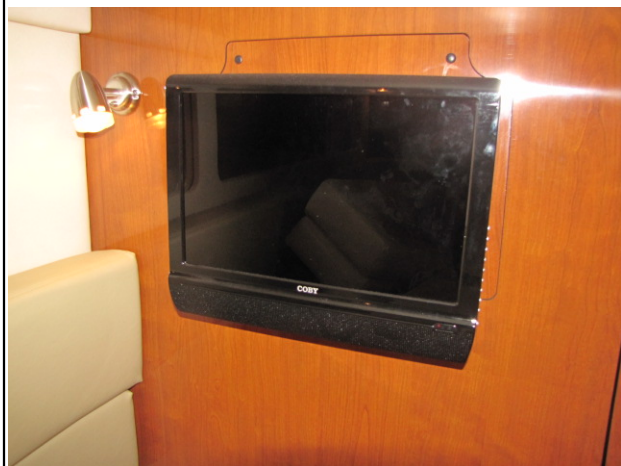
One (1) 19" Sylvania flat screen, One (1) 15" Coby flat screen. Powered up. See photo's 13,19.

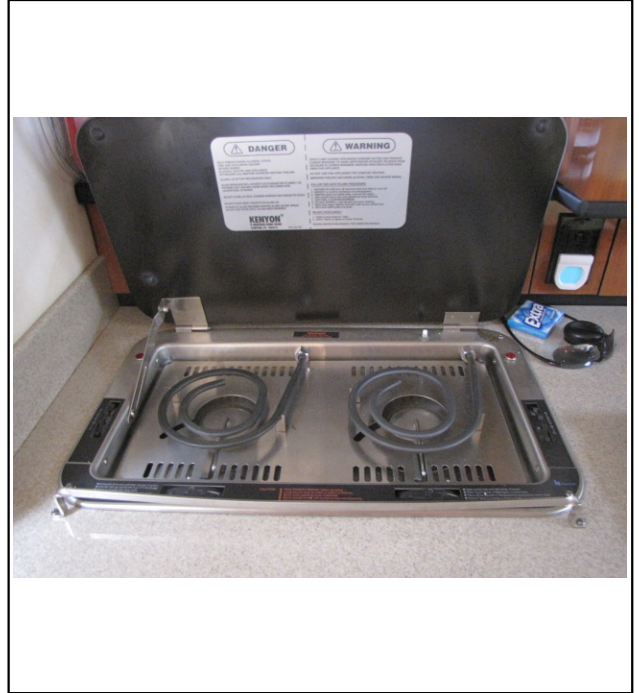
**Electric/Alcohol stove, photo 14.**

Kenyon, 2 burner electric/alcohol stove. Powered up. See photo 14.

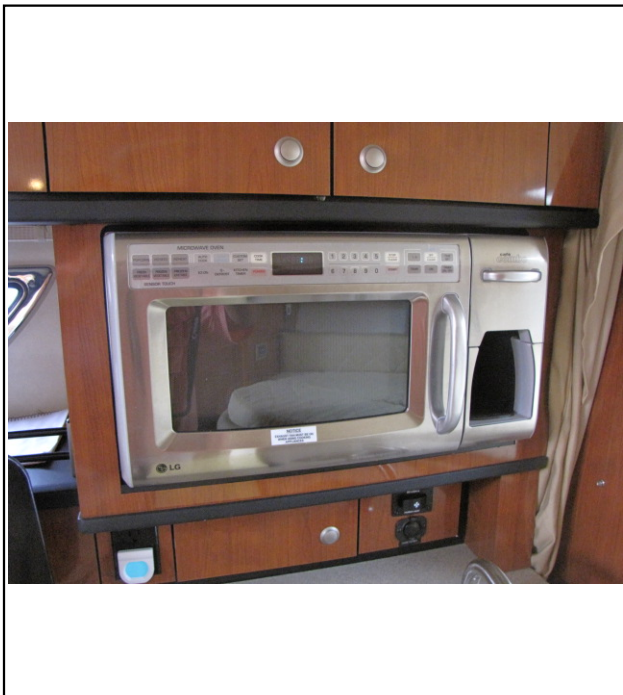
**Microwave oven, photo 15.**

LG, stainless steel microwave oven. Powered up. See photo 15.

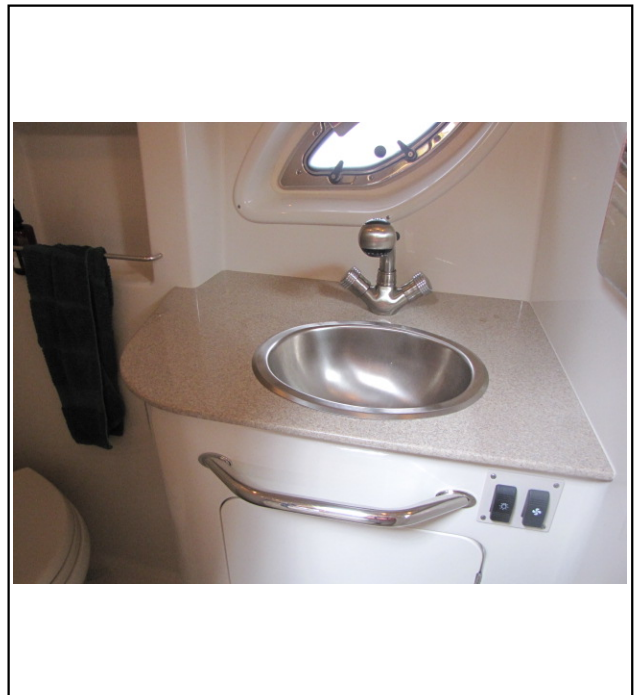
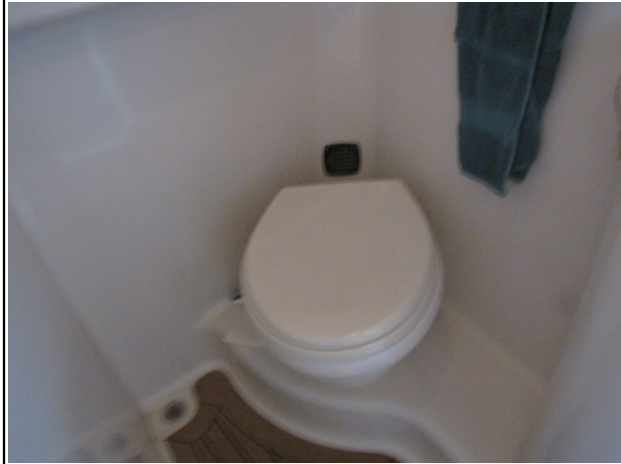
One (1) located at port cabin at entry. See photo's 16,17.

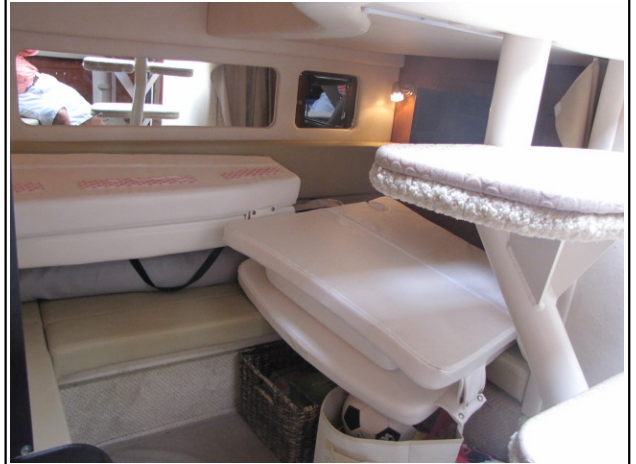
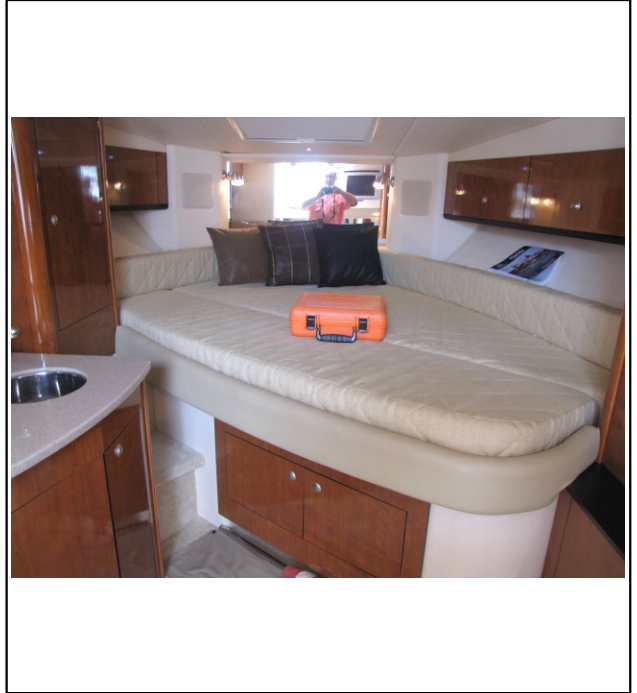
Accommodations provided by forward V-berth with privacy curtain, cabin sofa that converts to sleeper and a mid berth that provides a double bunk. See photo's 18,39,41. Serviceable.

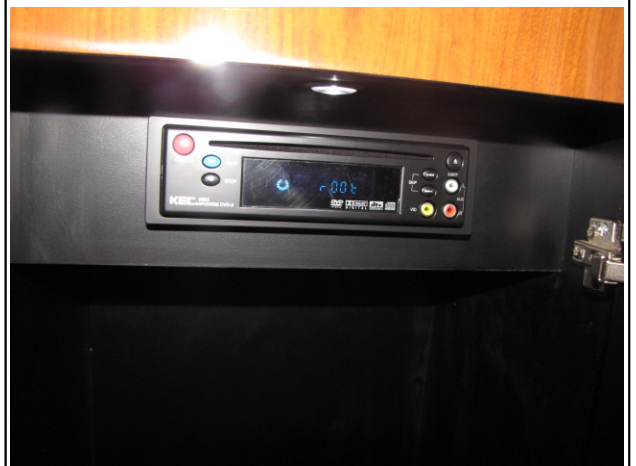
**DVD player, photo 20.**

Leather sofa sleeper with flat screen TV, DVD player and a wood table stored under V-berth mattress. Excellent condition. See photo's 13,20, 41.

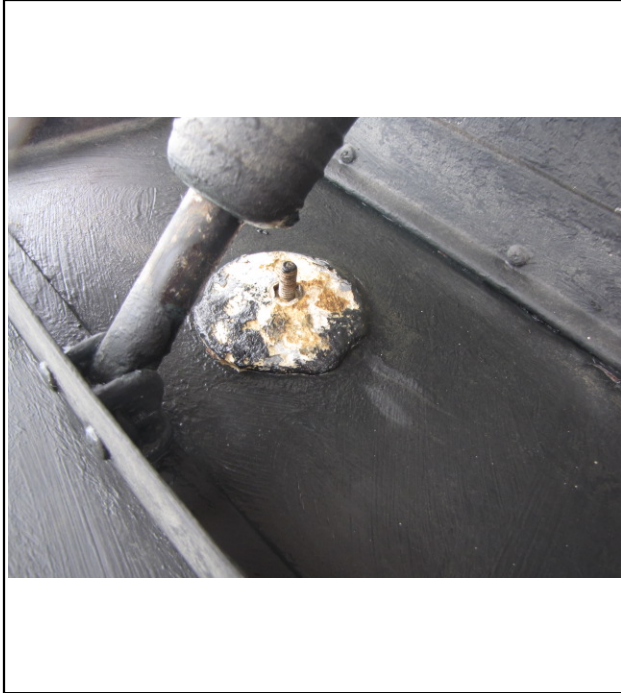
**Port Trim tab zinc, photo 21.**

One (1) hull Zinc sighted on transom under swim platform. Appeared serviceable. Two (2) Trim tab mounted zinc's.	
FINDINGS	RECOMMENDATIONS
Zincs mounted on trim tabs have wasted away. See photo's 21,22.	Replace with new.

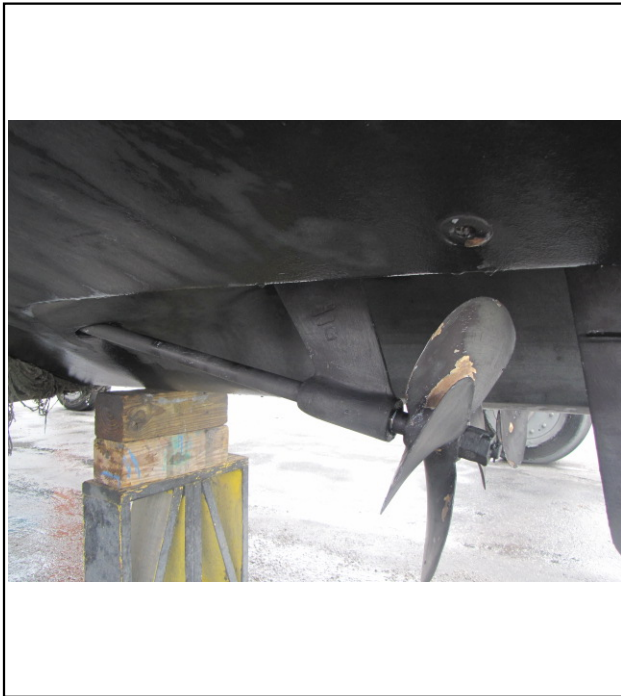
**Port prop, shaft, strut, rudder, photo 23.**

Stainless steel 1 1/4". Appear serviceable. See photo's 23,24.

Two (2) Bronze alloy 4 blade propellers. See photo's 23,24.	
FINDINGS	RECOMMENDATIONS
Surveyor detected a slight vibration coming from the port side of propulsion system. Possible propeller issue? Surveyor did not determine size and pitch of props due to heavy fresh bottom paint.	Remove, balance and repair prop for smooth operation.

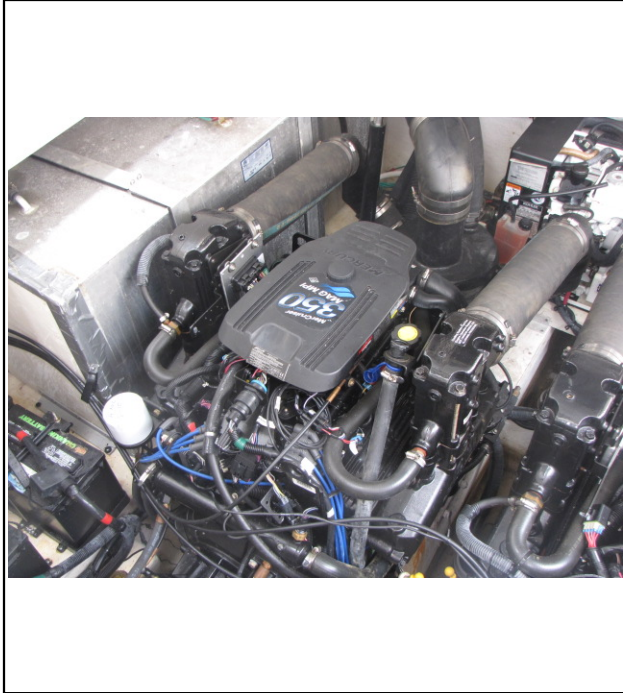
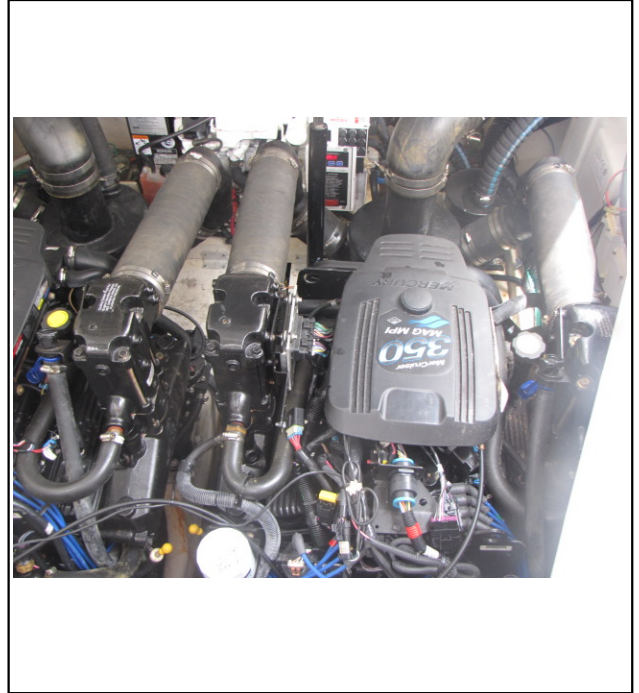
MerCruiser 350 MAG MPI. See photo's 29,30.

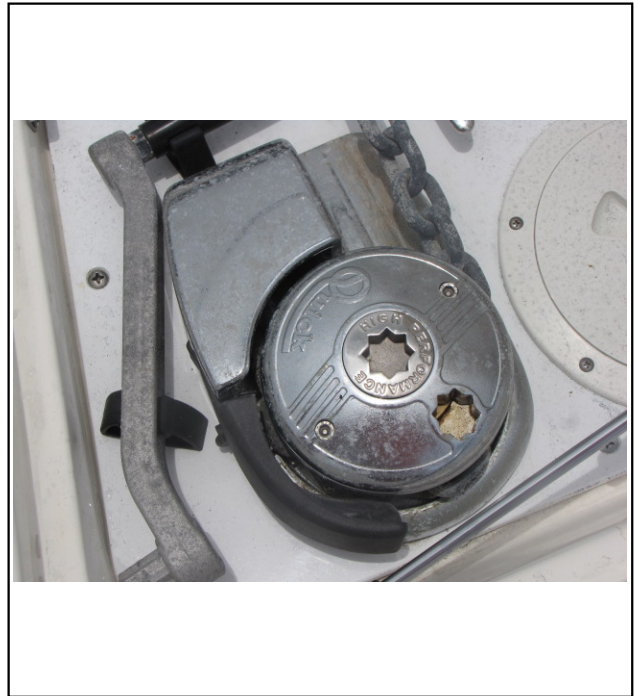
**Windless, photo 32.**

Quick High Performance. See photo 32. Serviceable.

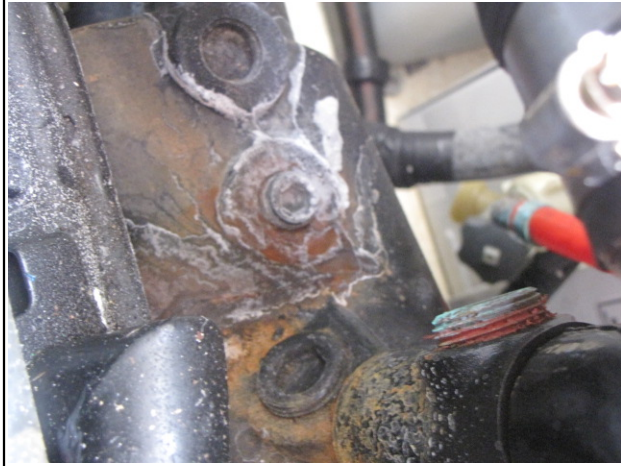
**Port outboard riser, photo 33.**

Outboard riser on the port engine was found heavily corroded and leaking water. See photo 33. Inboard manifold on the starboard engine indicated a leak due to a rust stain on the stringer below. See photo 34. Engine oil in both engines were found 1/2 to 1 quart low and very dirty. Surveyor detected a slight vibration on the port side of vessel at all RPM's. RPM's on the port engine only reached 4,350. Manufacture stated RPM's are 4600-5000. Surveyor recommends having a qualified Mercruiser technician address the issues stated and service both engines before next use. Engines started well and ran smoothly but seemed under powered for the size and displacement of vessel.

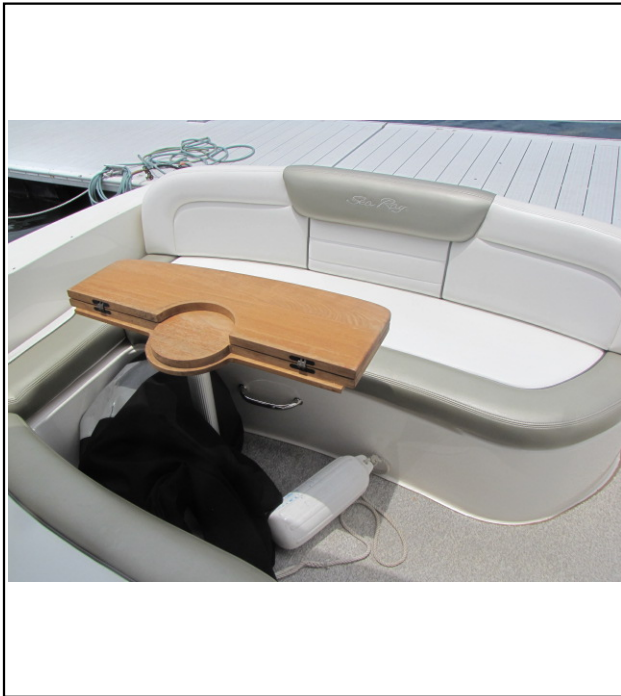
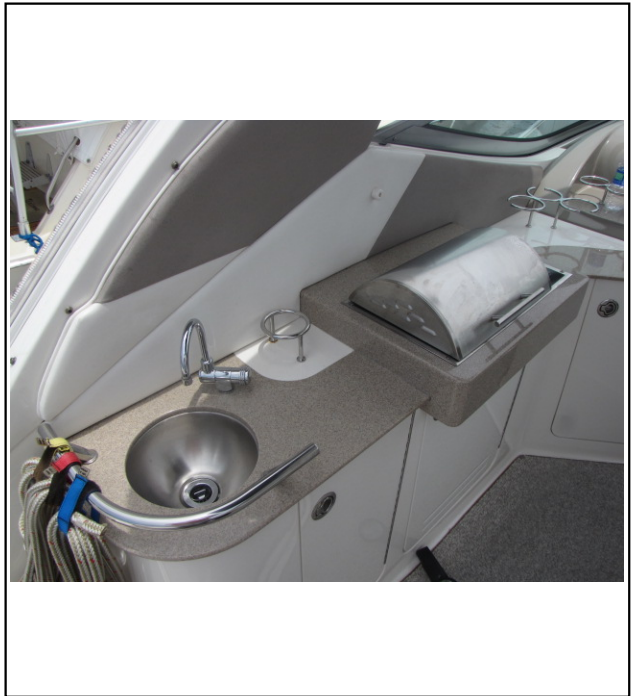
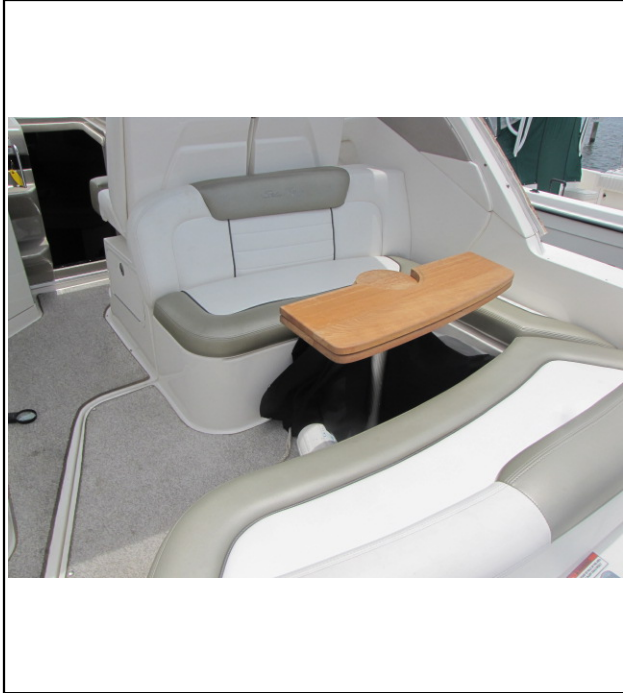
Cockpit is spacious and equipped with ample guest seating, deck carpet, and a wet bar with grill for entertaining family and friends. Excellent condition. See photo's 35,36,37.

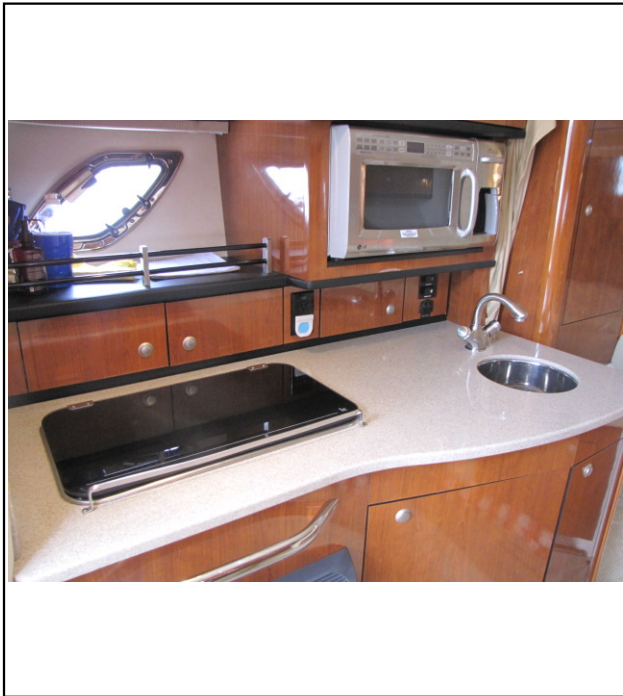
**Galley, photo 40.**

The joinery and finish of the cherry interior was very beautiful and in excellent condition. Serviceable. See photo 40.

Port side cabin. See photo 40.

Single oval stainless steel sink. Serviceable. See photo 40.

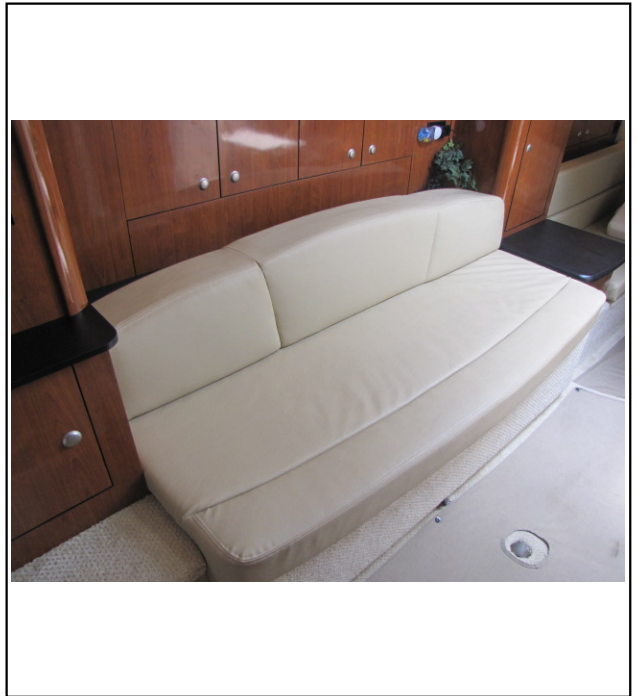
**Cabin lounge, photo 41.**

Cabin lounge seat cushions appear to be light colored leather. Excellent condition. See photo's 41.

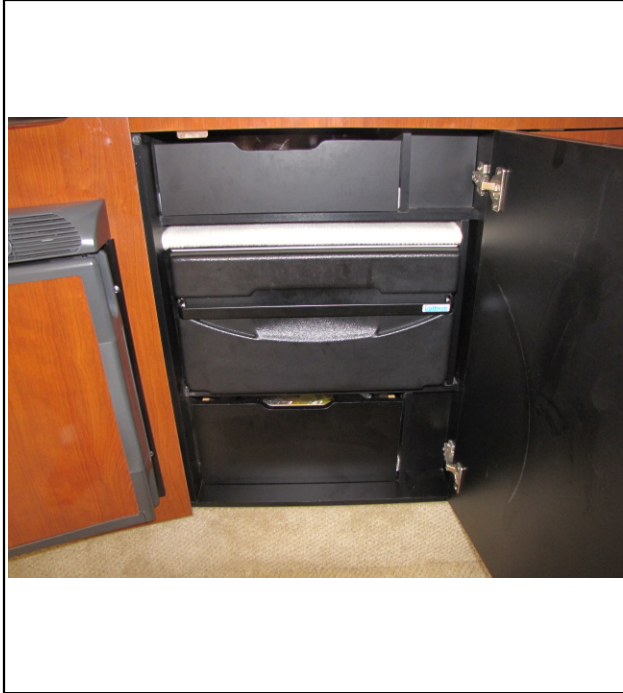
**Galley frig & freezer, photo 42.**

Norcold refrigerator with a Isotherm freezer. See photo 42. Powered up.

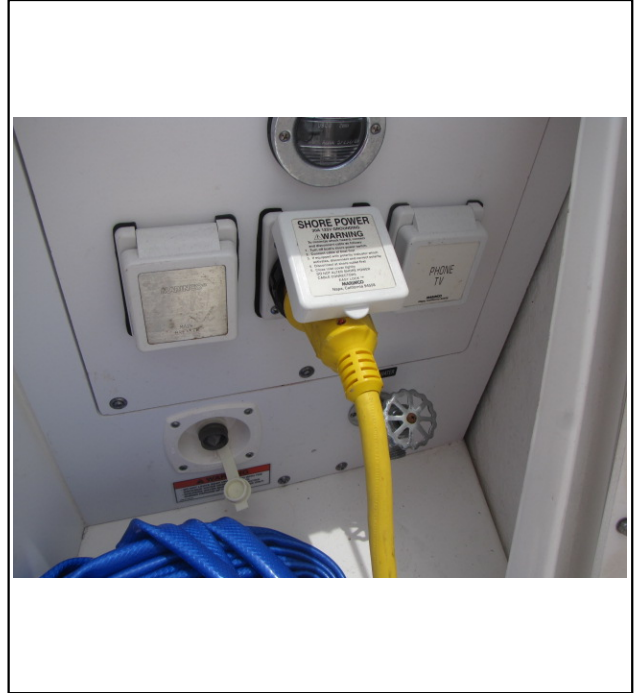
**Shore power connection & breaker, photo 43.**

One (1) Marinc 125V/30 amp. Located at starboard side stern. Serviceable. See photo 43.
